# **The Riparian Monitoring Program (RMP) Overview**

**Norma Posada, Watershed Engineer, P. Eng, M.Eng.  
The City of Calgary**

# RAP Key Action: *Monitor Riparian Health and Evaluate Performance*

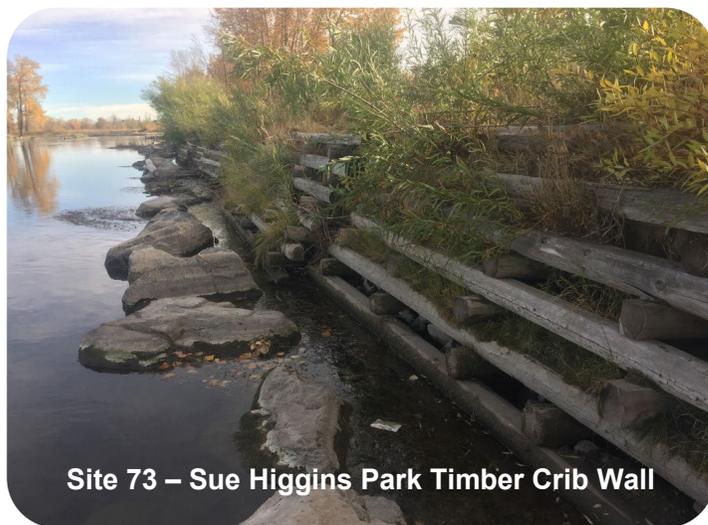
Site 73 – Sue Higgins Park Timber Crib Wall

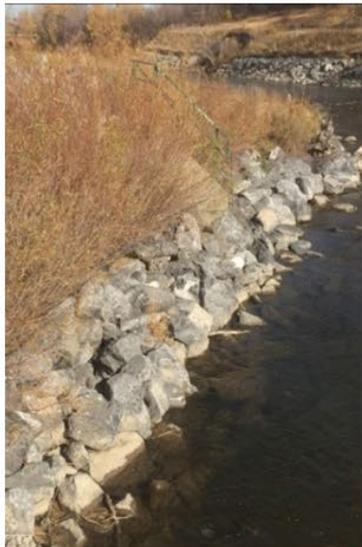
**Vegetated Riprap**  
Riprap bank protection with live cuttings inserted within the rock / joint planting

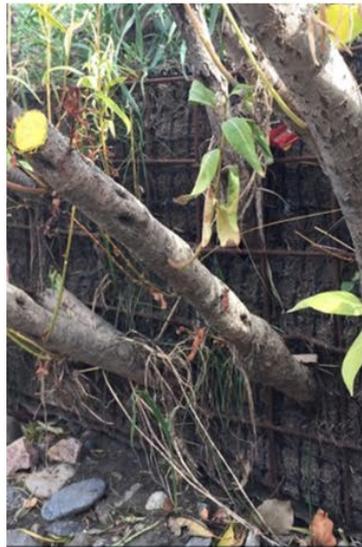
**Vegetated Retaining Wall**  
MSE walls, or vertical earth/concrete walls with live cuttings inserted

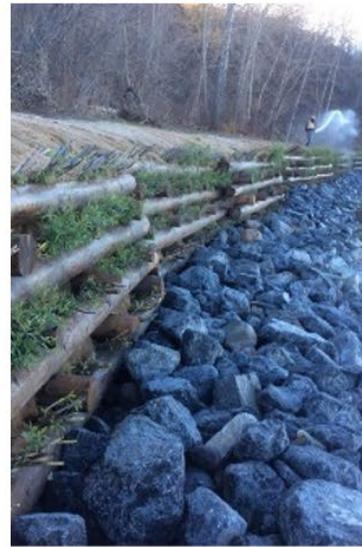
**Vegetated Crib Wall**  
Vegetated crib wall with live cuttings

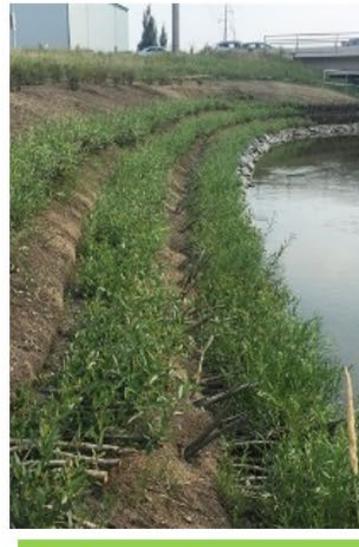
**Primarily Vegetative**  
Brush Mattresses / fascines / brush layers / wattle fences / live staking / vegetated soil wraps

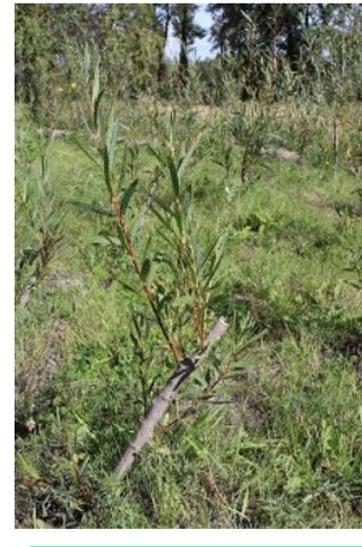
**Planting**  
Seeding, live staking and or rooted stock planted along shoreline of river and creek banks

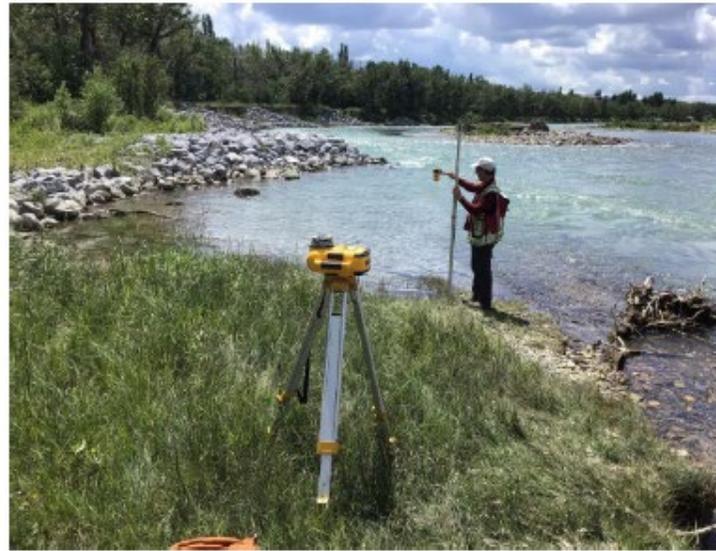
Photo 3-4: Existing vegetation elevation survey

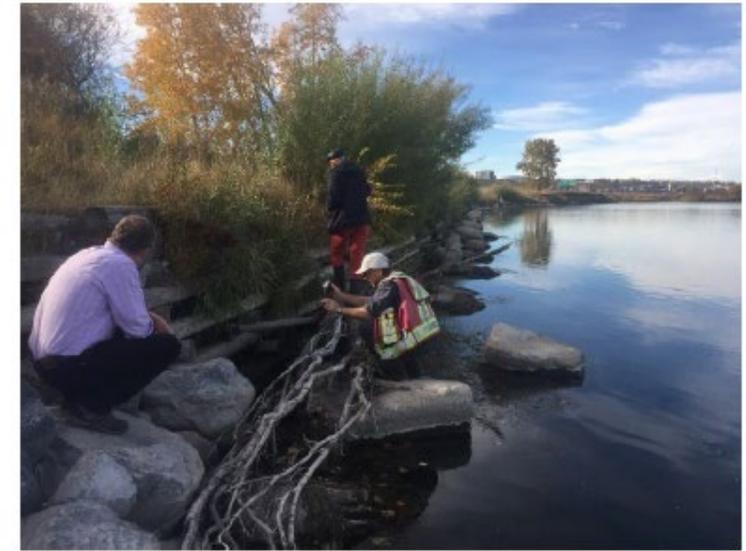
Photo 3-5: Structure assessment

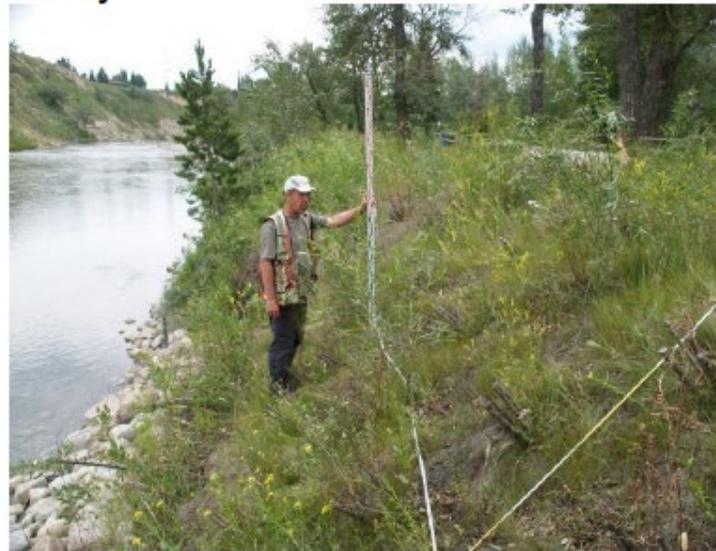
Photo 3-6: Pin-point transect

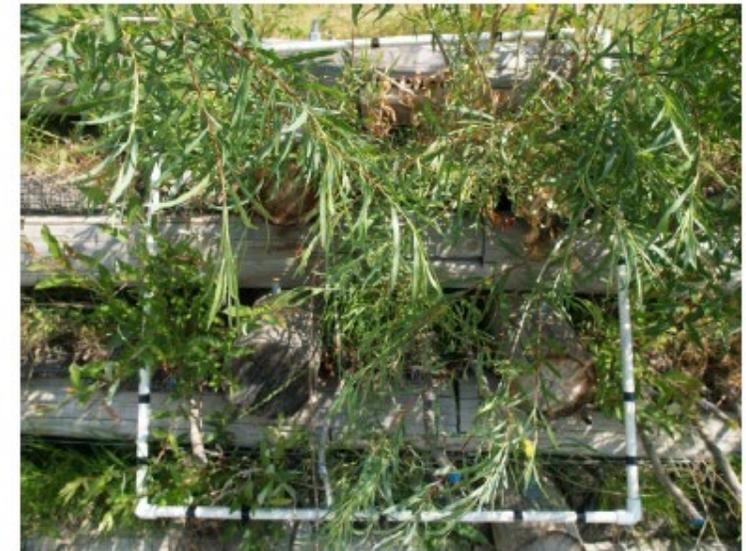
Photo 3-7: Quadrat
